Manhole Inspection Summary

Manhole # S17E1_019MH

Insp Date: **2/16/09 1:59 PM**

Location Address: **2831 MAUDLIN AV**

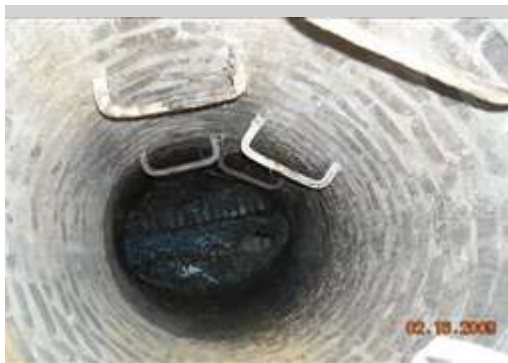
MISC.

POST CLEANING

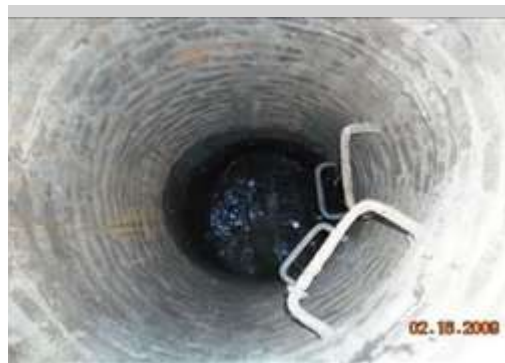
MISC.

TOP VIEW PRIOR TO CLEANING

Comments **HEAVY CLEANING FROM DOWNSTREAM MANHOLE S17E1_008MH TO REMOVE HEAVY GREASE AND DEBRIS DEPOSITS FROM CHANNEL.**

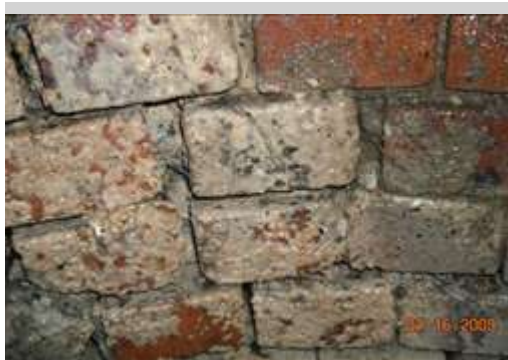
Defect 9

Condition: ☐ Sound ☐ Cracked ☐ Root Intrusion ☒ **Loose Brick** ☒ **Deteriorated**

LOOSE BARREL BRICKS FROM MISSING MORTAR

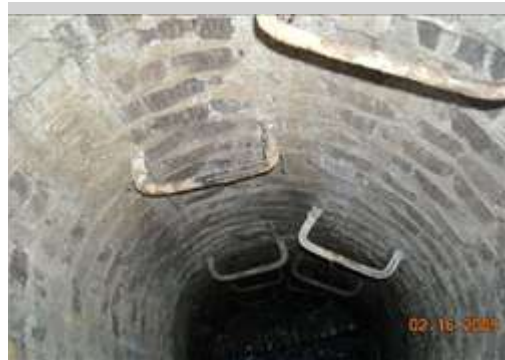
Defect 8

Steps Count: **9** Missing: **0** ☒ **Corroded**

CORRODED STEPS

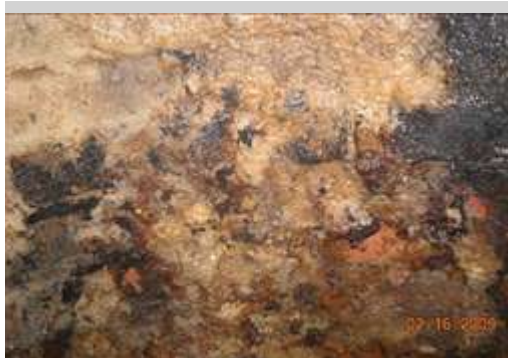
Defect 7

DETERIORATED BARREL WALL

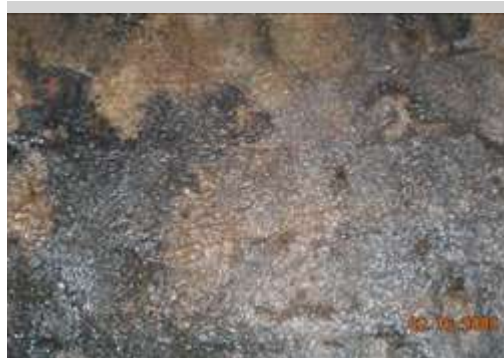
Defect 6

Infiltration: ☐ None ☐ Joint ☐ Cracks ☐ Mortar ☐ Roots ☒ **Wall**

INFILTRATION @ BARREL WALL

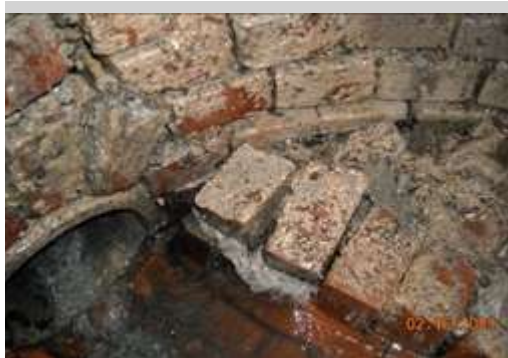
Defect 5

Condition: ☐ Sound ☐ Cracked ☐ Root Intrusion ☒ **Deteriorated** ☐ Leaks ☐ Debris

DETERIORATED BENCH; LOOSE
BENCH BRICKS WITH MISSING
MORTAR

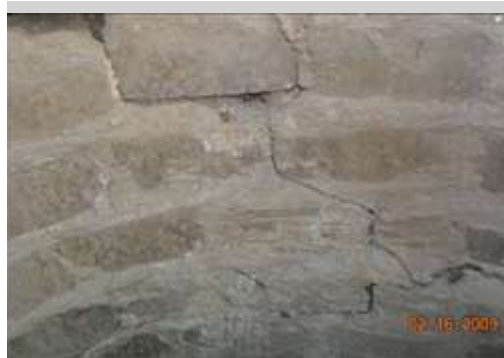
Defect 5

Condition: ☐ Sound ☒ **Cracked** ☐ Root Intrusion ☐ Loose Brick ☐ Deteriorated

CRACKED CORBEL BRICKS

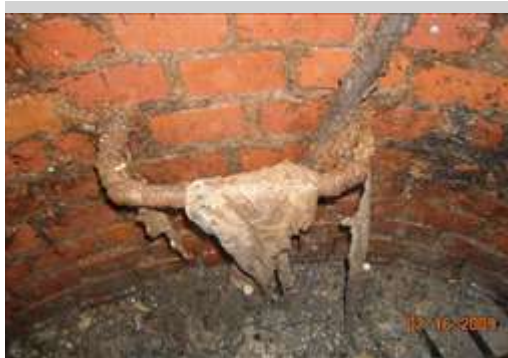
Defect 4

Surcharge ☒ **Evidence Of Surcharge** Depth: **6** (ft.) ☐ Active Surcharge Present

EVIDENCE OF SURCHARGE

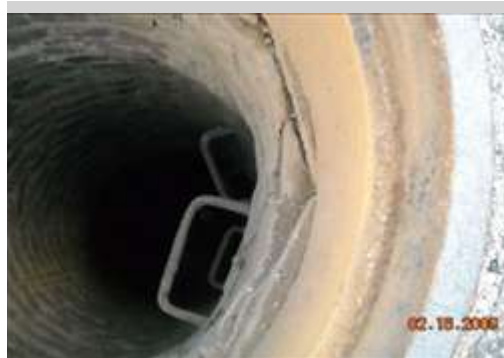
Defect 4

Frame Offset: **1** (in.) Condition: ☒ Sound ☐ Cracked ☐ Leaks

FRAME OFFSET

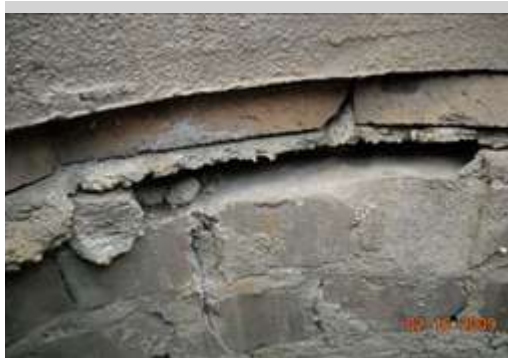
Defect 3

Condition: ☐ Sound ☐ Cracked ☐ Root Intrusion ☐ Loose Brick ☒ **Deteriorated**

DETERIORATED CHIMNEY; MISSING
MORTAR OR BRICK

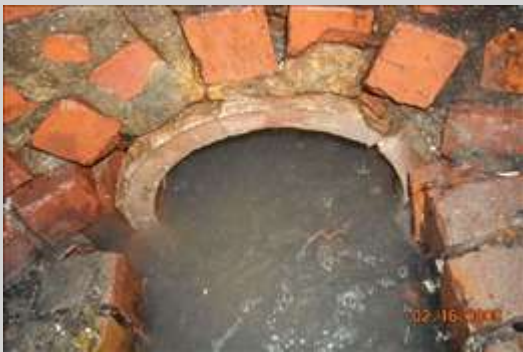
12 O'Clock Outflow

Pipe Height: **10.8** (in.) Rod and Bar (Angled)
Pipe Material: **Clay** ☐ Pipe Lined
Invert Depth: **15.75** (ft.) Flow Characteristics: **Fast**
Deposits: ☒ None ☐ Mud ☐ Sludge ☐ Debris ☐ Grease
Silt Depth: **0** (in.) Deposits Extent:
Infiltration: **None** Pipe Seal Cond: **Broken**

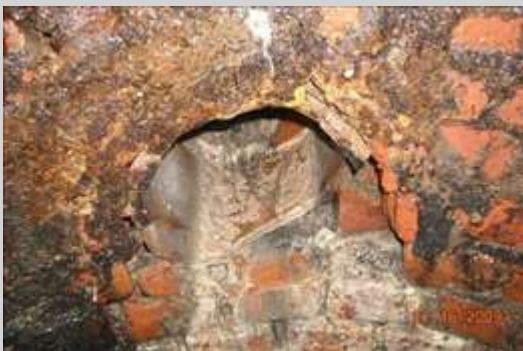
6 O'Clock Inflow

Pipe Height: **8.4** (in.) Rod and Bar (Angled)
Pipe Material: **Clay** ☐ Pipe Lined
Invert Depth: **13.50** (ft.) Flow Characteristics: **Fast**
Deposits: ☒ None ☐ Mud ☐ Sludge ☐ Debris ☐ Grease
Silt Depth: **0** (in.) Deposits Extent:
Infiltration: **None** Pipe Seal Cond: **Broken**
